## **Statement of Corrective Actions Undertaken in Response to September 29, 2005 Property Condition Assessment Report by STS Consultants.**

# **PROPERTY CONDITION ASSESMENT REPORT**

**WASHINGTON SQUARE APTS  
118 S. WASHINGTON STREET  
GREEN BAY, WISCONSIN**

**September 29, 2005**

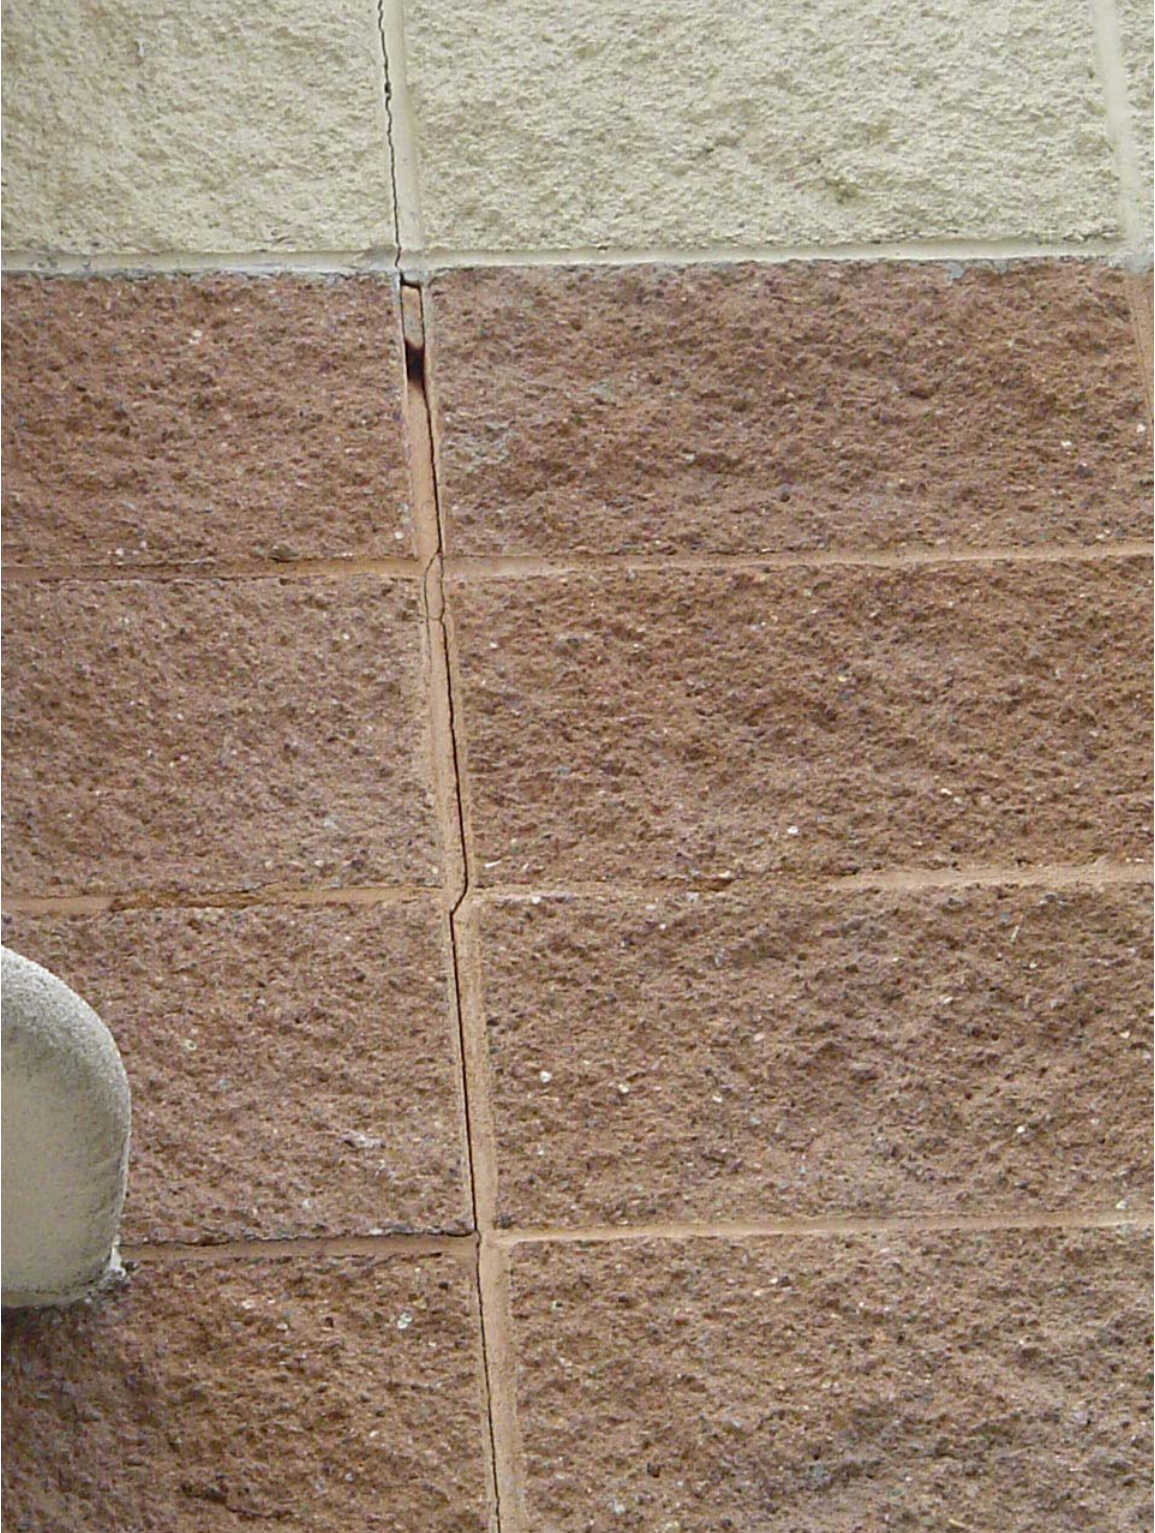
**Building "A": Exterior Wall at Washington Street**

- Minor cracking at some of the mortar joints at the Washington Street side near the entryways.

- Minor cracking of mortar joints at Washington Street near entry (Page 19)  
*Declarant is currently collecting contractor bids for tuck pointing areas of the brick facing that are missing mortar. Declarant expects the work to be completed by the end of the year (2005).*
- Exterior insulation and finish system (EIFS) repairs (Pages 19 & 23)  
*Declarant is currently collecting contractor bids for the repairs to the EIFS. Depending on weather, Declarant expects repairs noted in STS report to be completed either in the fall of 2005 or spring of 2006.*
- Missing joint material (Page 19)  
*Declarant will contract to repair this issue before the end of the year (2005).*
- Foundation wall protective coating (Page 23)  
*Declarant will have the onsite maintenance department repair the protective coating noted in the report by the end of the year (2005).*

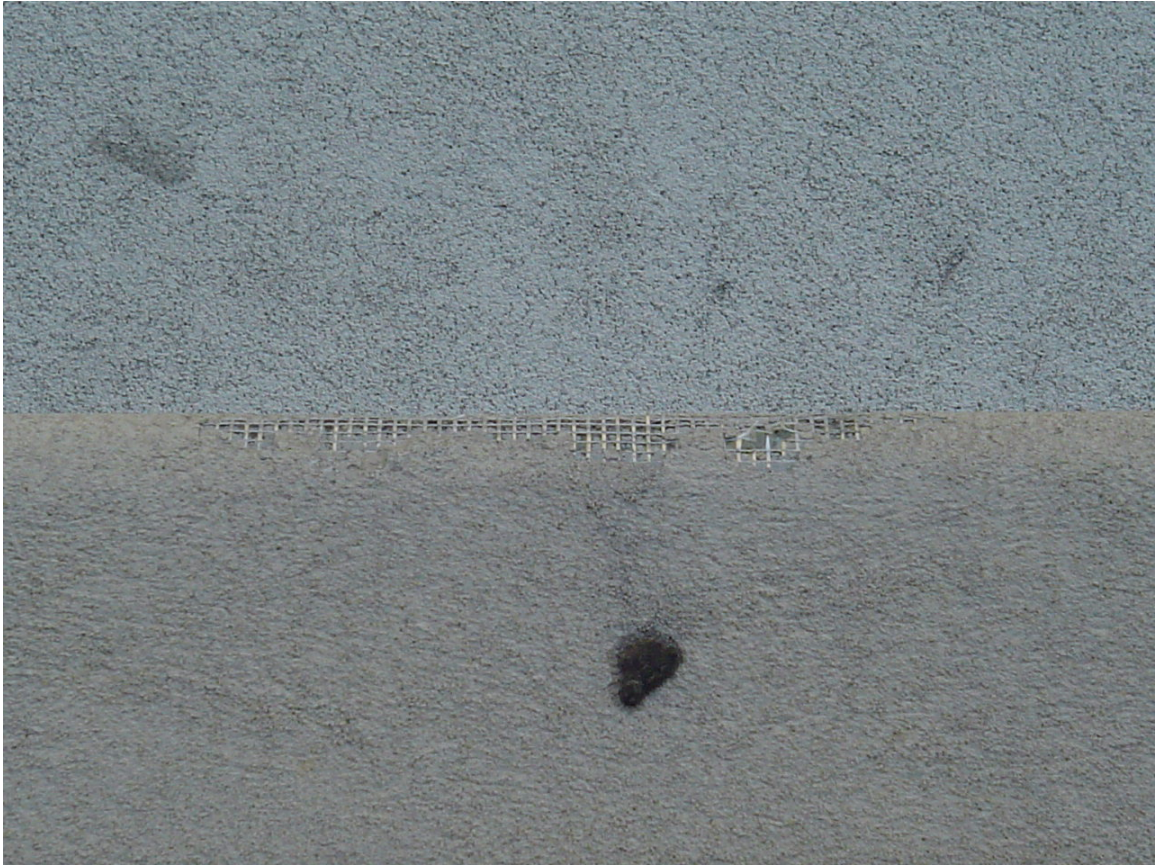
**Building "A" Cornice at Room 232**

- Minor EIFS damage at the cornice of the 2<sup>nd</sup> story (room 232).

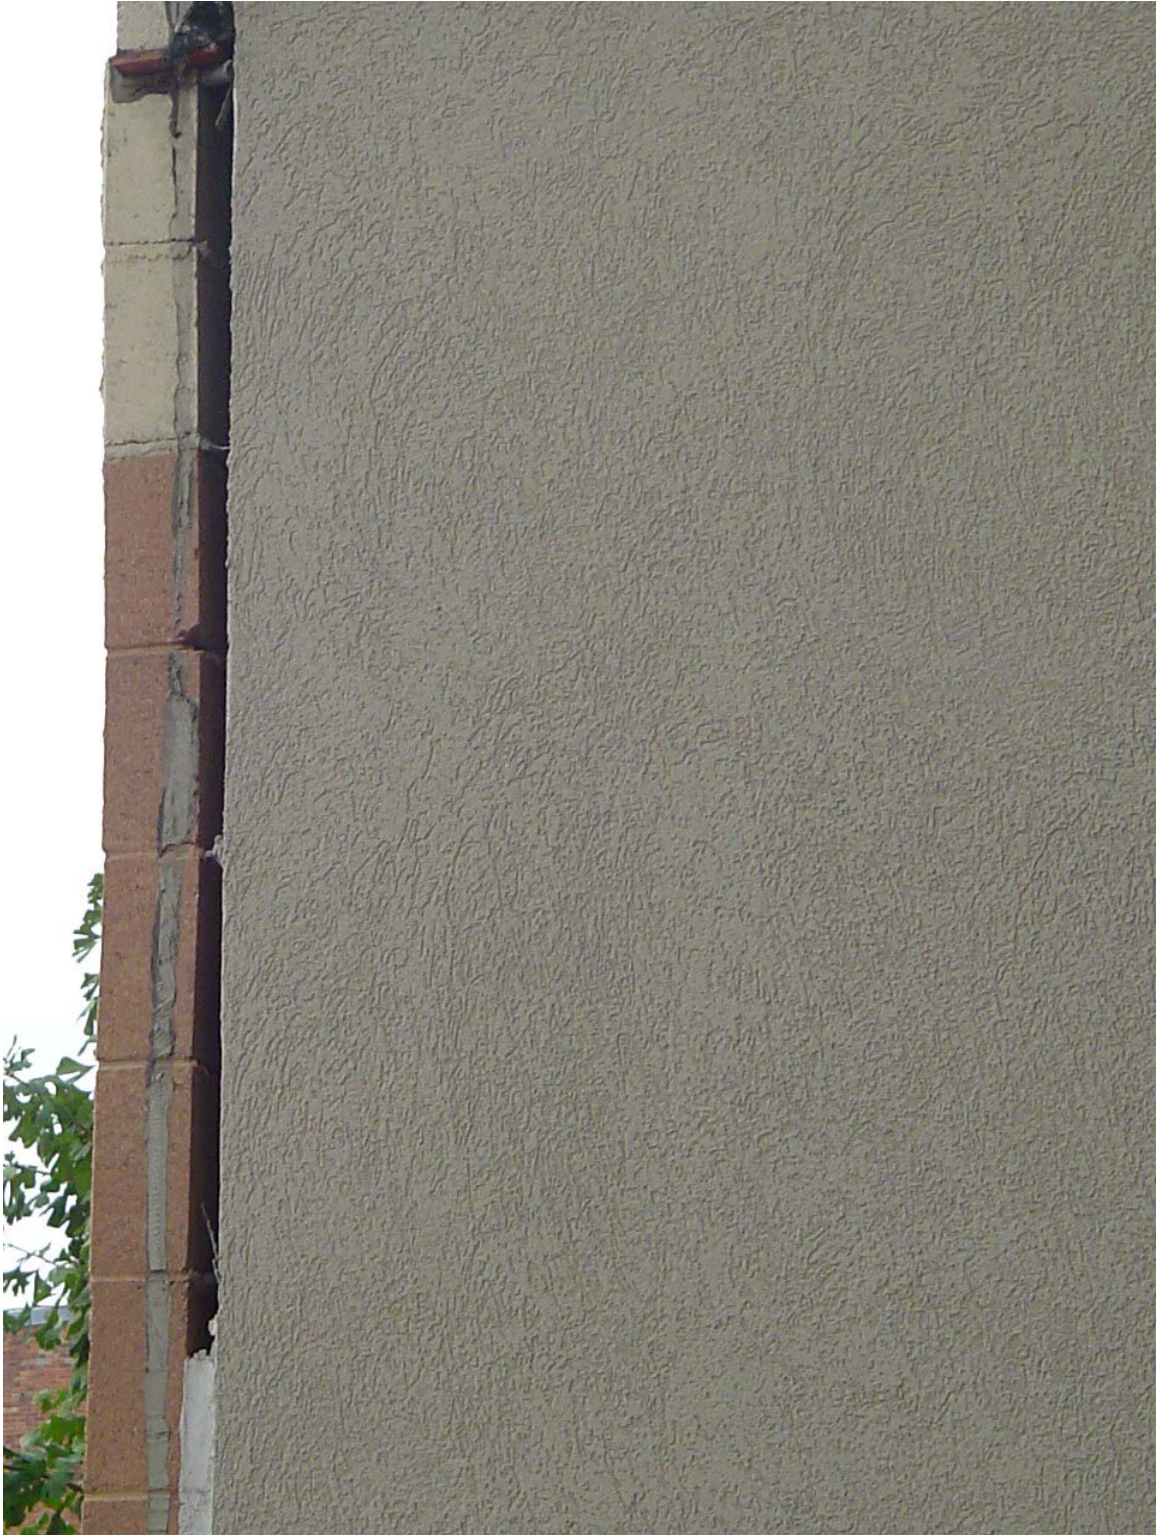
**Building "A" North Wall, Washington Street Side**

- Missing joint material or minor cracking at ends of brick façade on the north wall at both the east and west corners of the building.

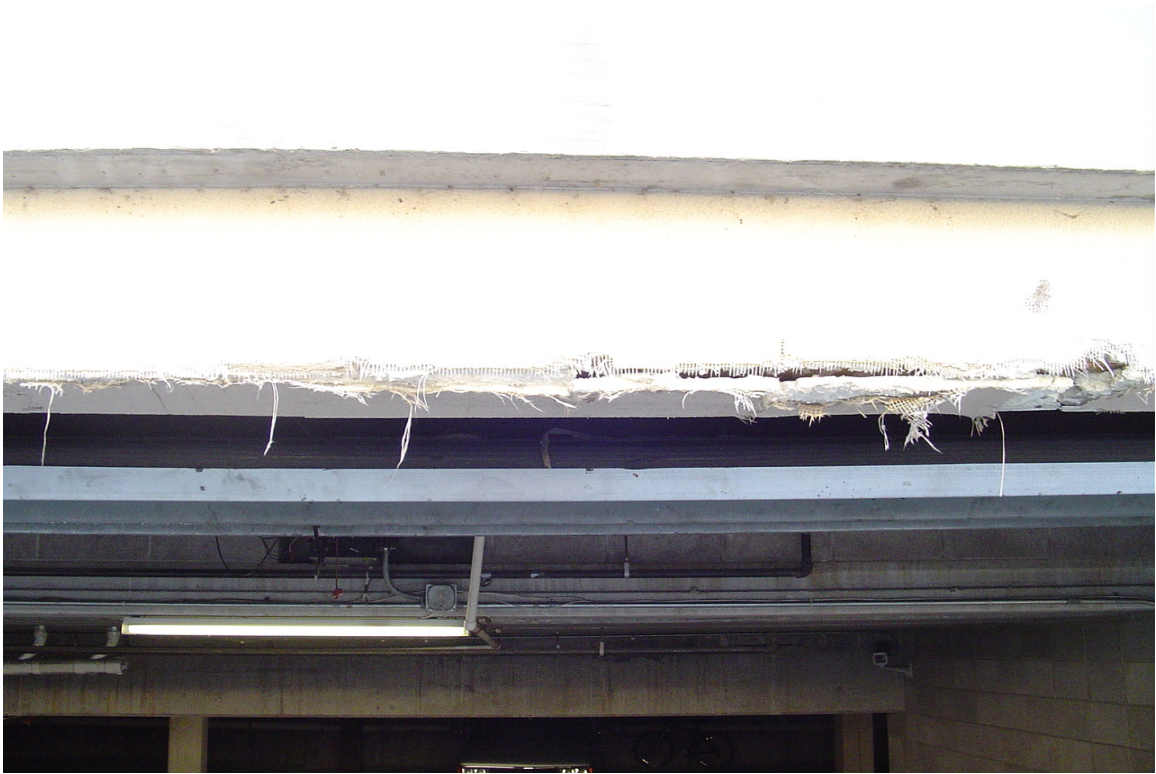
**Building “B” EIFS Header at Parking Overhead Door Entrance**

Significant EIFS damage at underground parking overhead door header.

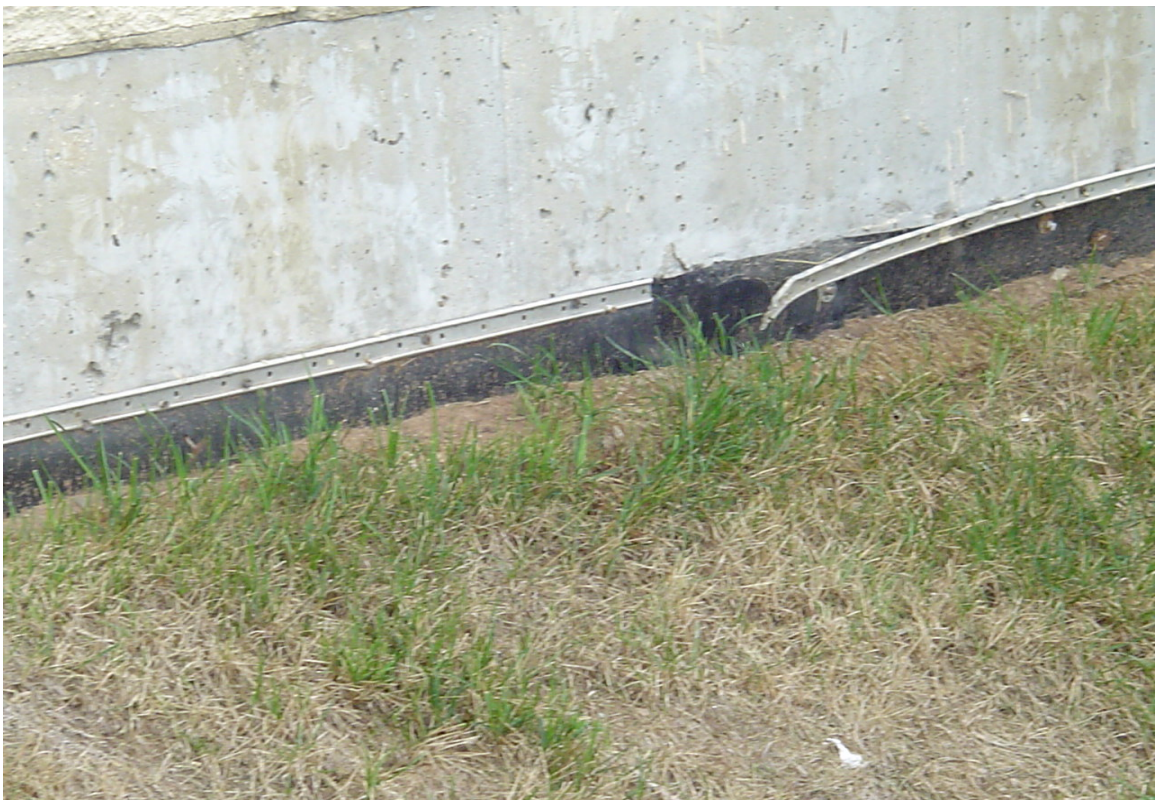
**Building “B” Exterior View at Northwest Corner**

At the northwest corner of the building, the top of the foundation wall protective covering is becoming exposed and the anchorage is becoming damaged from the exposure.

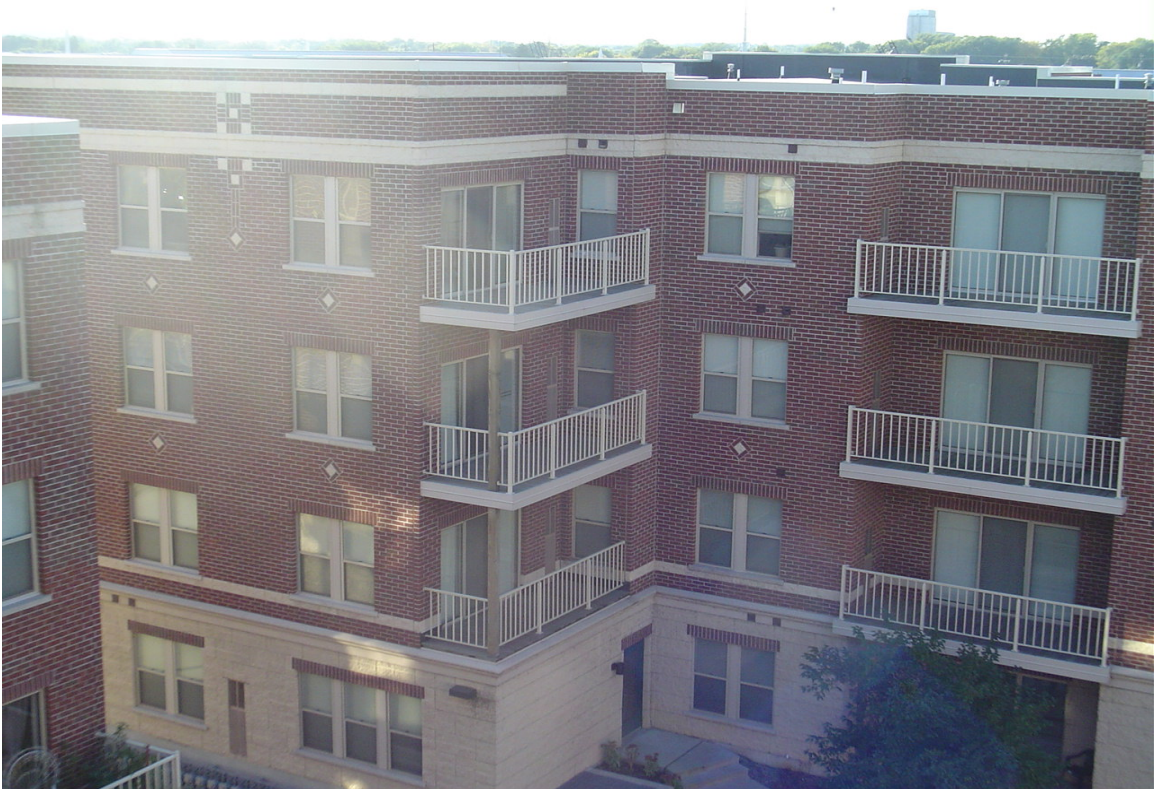
**Building "B" Exterior View Looking Southwest**

At the south wall of the building, the top of the foundation wall protective covering is exposed. The covering and the anchorage is becoming damaged from the exposure.
